Manhole Inspection Summary

Manhole # S25CC_064MH

Insp Date: **7/16/07 11:30 AM**

Location Address: **1027 CAREY-STOCKTON**

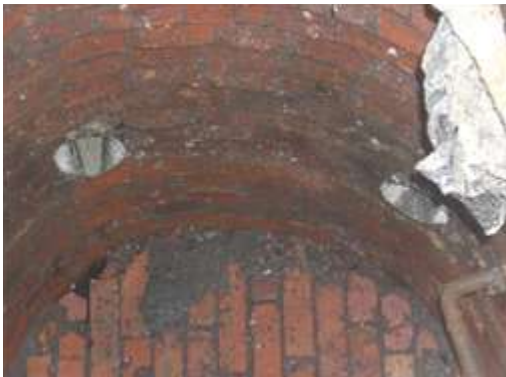
4" service pipes

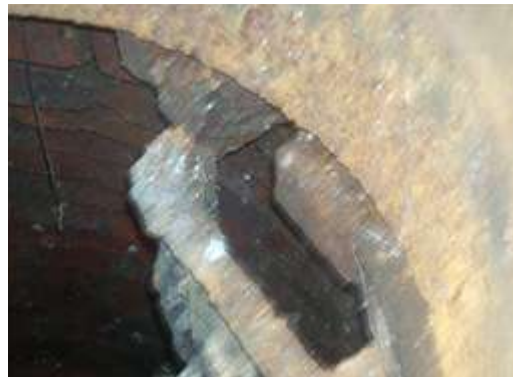
Defect 1

Condition: ☐ Sound ☐ Cracked ☐ Root Intrusion ☒ **Loose Brick** ☐ Deteriorated

LOOSE CHIMNEY BRICKS

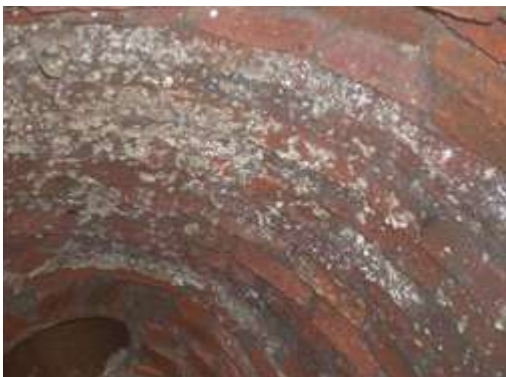
Defect 2

☒ **Evidence Of Surcharge** Depth: **3** (ft.) ☐ Active Surcharge Present

SURCHARGE EVIDENCE

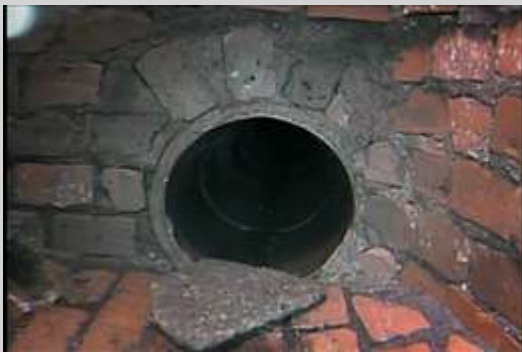
12 O'Clock Outflow

8 in. Circular Gravity Sewer
Pipe Out @ 12 O'Clock

Pipe Height: **7.2** (in.) Rod and Bar (Angled)
Pipe Material: **Clay** ☐ Pipe Lined
Invert Depth: **5.68** (ft.) Flow Characteristics: **None**
Deposits: ☐ None ☐ Mud ☐ Sludge ☒ **Debris** ☐ Grease
Silt Depth: **2** (in.) Deposits Extent: **Medium**
Infiltration: **None** Pipe Seal Cond: **Sound**

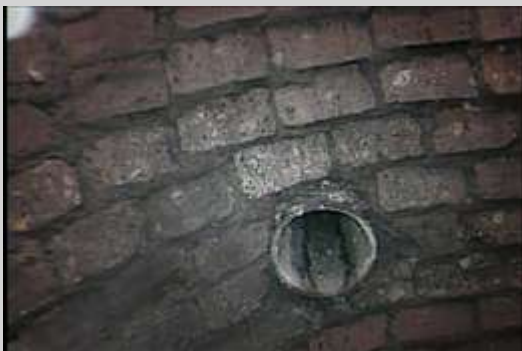
6 O'Clock Inflow

4 in. Circular Gravity Sewer
Pipe In @ 6 O'Clock

Pipe Height: **4.8** (in.) Rod and Bar (Angled)
Pipe Material: **PVC** ☐ Pipe Lined
Invert Depth: **4.20** (ft.) Flow Characteristics: **None**
Deposits: ☒ **None** ☐ Mud ☐ Sludge ☐ Debris ☐ Grease
Silt Depth: (in.) Deposits Extent:
Infiltration: **None** Pipe Seal Cond: **Sound**

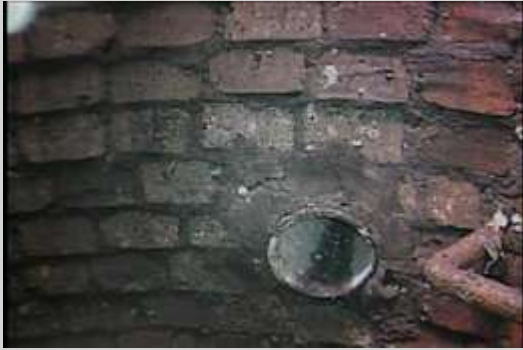
8 O'Clock Inflow

4 in. Circular Gravity Sewer

Pipe In @ 8 O'Clock

Pipe Height: **4.8** (in.) Rod and Bar (Angled)
